Concrete Mine Thickener Tank Repaired with Hybrid CP

Ian Godson & Luke Thompson
– Infracorr Consulting Pty Ltd

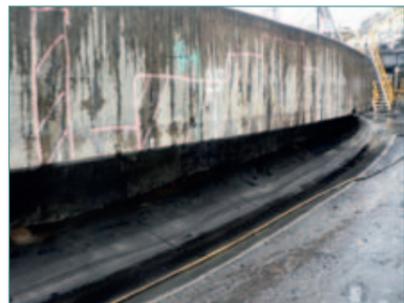
In November 2010 Infracorr Consulting Pty Ltd (formerly Ian Godson & Associates) was consulted to provide a repair specification to an 80m diameter coal thickener tank suffering from significant concrete deterioration issues. The 3m high tank at Curragh Coal Mine, located near Blackwater Queensland, was suffering from corrosion of the reinforcement due to chloride contamination from the treatment water in the tank, with severe spalling and delamination especially in the external launder wall. Corrosion surveys also indicated that sections of the main tank walls and the service tunnel beneath the tank were also corroding, with less visible spalling.

Corroded Reinforcement causing concrete spalling in the external launder wall of the tank

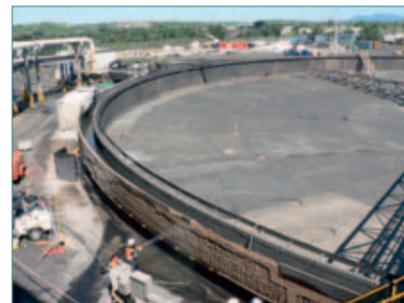
Coal Thickener Tank during 2 week shutdown. Hydro-demolition & dry process gunite progressing around the tank.

The works commenced in late January 2011, with hydro-demolition utilized around the clock to maximize the productivity of defective concrete removal which was required up to but not behind the bar. The exposed reinforcement was checked for electrical continuity with isolated problems resulting in a 6mm continuity bar being required, tack welded to all vertical bars around the tank. Dry process gunite closely followed the hydro-demolition and continuity work, restoring the concrete to the original profile, with cover to the reinforcement of approximately 20mm. All hydro-demolition and gunite repair was completed during the tank shutdown of two weeks, with the tank re-filled and restored to full operating condition by mid February 2011.

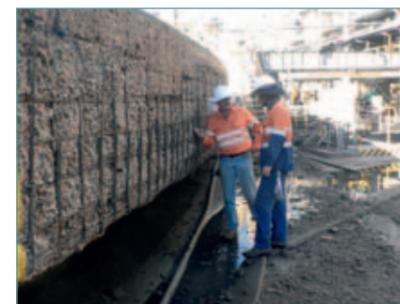
Launder wall after hydro-demolition has removed the delaminated and spalling concrete.

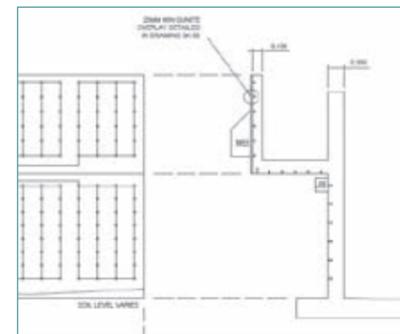
Part drawing of hybrid anode arrangement. The launder wall was treated with short (D175) hybrid anodes with an overlay of 25mm gunite to reduce risk of drilling through the wall.

The largest challenge was the anode design to protect the very thin launder wall section which was only 150mm thick and reinforced with a single mat of reinforcement. To minimize the risk of drilling through the launder tank wall, the short DuoGuard 175 anodes, 44mm long, were designed to be installed into 60mm deep holes of 30mm diameter, with controlled depth

drilling to eliminate the risk of penetrating to the operating (full) tank. A dry process gunite overlay of 25mm was then to be placed over the outer surface of the launder wall, providing cover to the anode system.

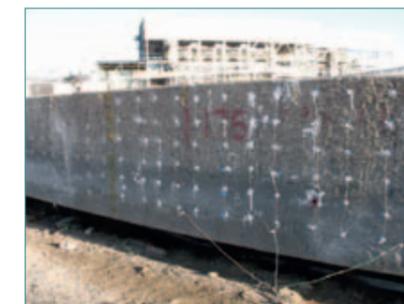
Anodes Installed in Proprietary Paste backfill and powered at 12V from the temporary transformer rectifiers

The anode installation was completed progressively around the tank. Permanent reference electrodes ($MnMnO_2$) were installed initially with 36 installed in monitoring areas around the tank. The 30mm diameter holes were percussively drilled initially and soaked with water for 24 hours to maximize the moisture in the concrete. The anodes were installed in the holes in the alkaline paste backfill in batches (sub-zones), checked for isolation from the reinforcement and immediately powered by the temporary transformer rectifiers at 12 volts. The impressed current was maintained at 12 Volts for a minimum of 7 days, with the current recorded daily in each sub-zone. A minimum current criterion of 50 KC/m² reinforcement area was maintained to ensure the reinforcement was completely passivated. Once the impressed current criteria was met, the system

was converted into galvanic mode with the reinforcement negative connection connected to the titanium anode connection in the distributed junction boxes (24 No) around the tank. The galvanic current achieved averaged between 2 to 3 mA/m² reinforcement. Following the installation of the anode system, the 25mm layer of dry process gunite was applied over the entire outer launder wall.

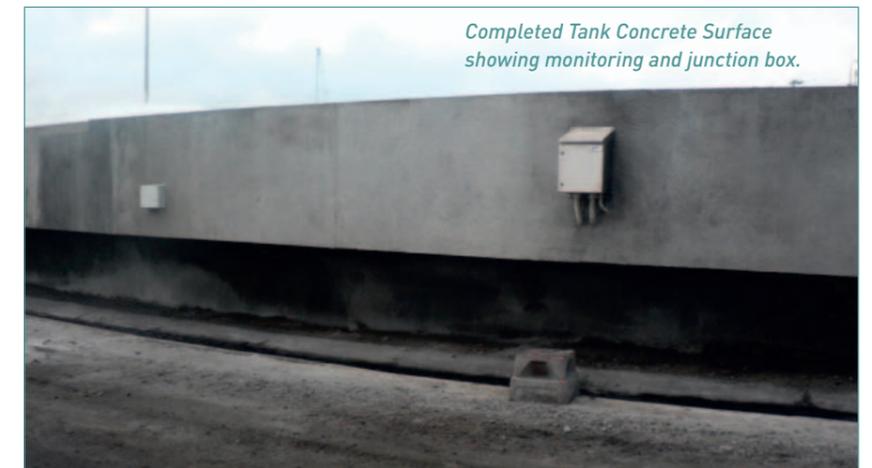
Completed Tank Concrete Surface showing monitoring and junction box.

The overall system was finalised with the installation of a remote monitoring system that was designed to take galvanic current and depolarization readings and update those to an internet database, allowing considerable travel cost and time savings for the monitoring process.
